**DEPARTMENT OF TRANSPORTATION**

Contract #: 04-0120F4Cty: SF/ALA Rte: 80 PM: 13.2/13.9File #: 1.28**WELDING INSPECTION REPORT****Resident Engineer:** Casey, William**Address:** 333 Burma Road**City:** Oakland, CA 94607**Report No:** WIR-030062**Date Inspected:** 23-Sep-2013**Project Name:** SAS Superstructure**OSM Arrival Time:** 700**Prime Contractor:** American Bridge/Fluor Enterprises, a JV**OSM Departure Time:** 1730**Contractor:** American Bridge/Fluor Enterprises, a JV**Location:** Job Site**CWI Name:** William Sherwood**CWI Present:** Yes No**Inspected CWI report:** Yes No N/A**Rod Oven in Use:** Yes No N/A**Electrode to specification:** Yes No N/A**Weld Procedures Followed:** Yes No N/A**Qualified Welders:** Yes No N/A**Verified Joint Fit-up:** Yes No N/A**Approved Drawings:** Yes No N/A**Approved WPS:** Yes No N/A**Delayed / Cancelled:** Yes No N/A**Bridge No:** 34-0006**Component:** SAS Tower Skirt**Summary of Items Observed:**

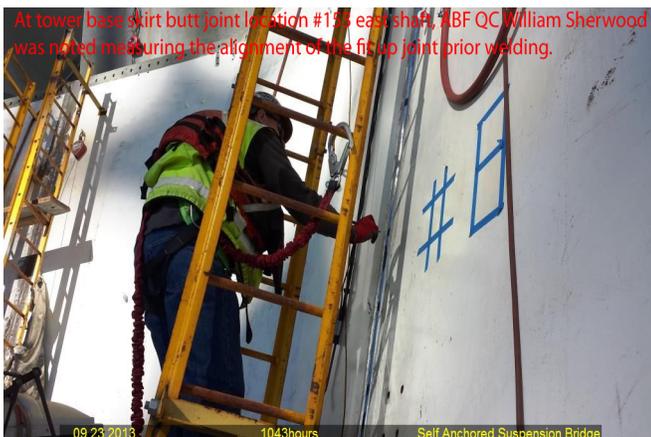
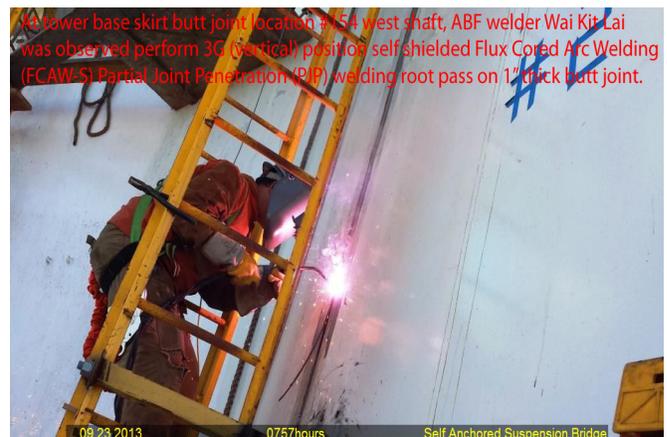
At tower base ring beam skirt weld joint #157 east shaft, this QA randomly observed ABF welder Rick Clayborn continuing to perform Partial Joint Penetration (PJP) welding 1" thick plate butt joint. The fit up and alignment was previously checked by ABF QC and verified by QA. The welder was observed butt welding the 1" skirt plate from Y=0 to Y=2500mm in 3G (vertical) position utilizing self shielded Flux Cored Arc Welding (FCAW-S) with 0.072" diameter E71T-8 wire electrode implementing Caltrans approved Welding Procedure Specification (WPS) ABF-WPS-D15-2140-3. Prior welding, the welder was noted preheating the plates to more than 200°F using propylene gas torch. During welding, ABF QC Inspector Tony Sherwood was noted on site monitoring the workmanship and welding parameters of the welder with measured working current of 268 amperes and 21.5 voltage. The welding parameters appear in compliance to the working WPS. During the shift, the welder has welded the root pass, fill pass and cover pass of the weld joint location mentioned above.

After the completion of the ring beam skirt weld #157 east shaft, the same welder has moved to another skirt weld location #153 east shaft. The welder has ground the weld area to bright metal before ABF QC William Sherwood performed the fit up inspection. During the fit up inspection, QC has noted the alignment less the 2mm but the root opening has exceeded the maximum allowed by the approved WPS. The following root opening measurements were noted;

Since the root opening has exceeded the WPS requirements, a Caltrans approved Request for Information (RFI) #ABF-RFI-003417R02 has allowed ABF to use a backing bar where the root opening was greater than 8mm. ABF personnel were noted installing the backing bar prior welding. This QA randomly observed ABF welder Rick Clayborn continuing to perform Partial Joint Penetration (PJP) welding 1" thick plate butt joint. The fit up and alignment was checked by ABF QC and verified by QA. The root opening measurements were also brought to the attention of ABF Engineers and Caltrans prior to proceed welding. It was later agreed that the areas that exceeded 8mm should be buttered to close the gap then weld the root pass without bridging.

At tower base ring beam skirt weld joint #154 west shaft, this QA randomly observed ABF welder Wai Kit Lai continuing to perform Partial Joint Penetration (PJP) welding 1" thick plate butt joint. The fit up and alignment was previously checked by ABF QC and verified by QA. The welder was observed butt welding the 1" skirt plate from approximately Y=250 to Y=5220mm in 3G (vertical) position utilizing self shielded Flux Cored Arc Welding (FCAW-S) with 0.072" diameter E71T-8 wire electrode implementing Caltrans approved Welding Procedure Specification (WPS) ABF-WPS-D15-2140-3. Prior welding, the welder was noted preheating the plates to more than 200°F using propylene gas torch. During welding, ABF QC Inspector Tony Sherwood was noted on site monitoring the workmanship and welding parameters of the welder with measured working current of 270 amperes and 21.3 voltage. The welding parameters appear in compliance to the working WPS. During the shift, the welder has welded the root pass, fill pass and cover pass of the weld joint location mentioned above.
